CHECK CONTROL MESSAGE: "DRIVETRAIN: ONLY ELECTRIC DRIVE POSSIBLE"

I01 (I3 REx)

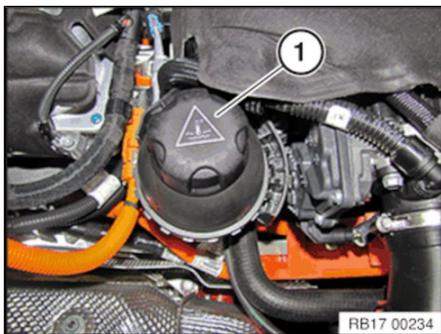
Leaking coolant expansion tank.

2. Check the tank and connected hoses for damage. **Are the tank or hoses damaged?**

3. Check the expansion tank for proper mounting to the REx (1). **Is the expansion tank loose from its mount?**

YES - Replace the expansion tank or hoses, as necessary. Refer to Repair Instruction: **17 13 025 Removing and installing/replacing coolant expansion tank for range extender (I01)**. Go to step 4.

YES- Remount properly. Go to next step.

4. Bleed and fill the cooling circuit. Refer to Repair Instruction **17 00...Bleeding and filling cooling circuit (high-temperature cooling system) for range extender with vacuum filling unit** for filling the cooling system after replacing expansion tank or hoses.
5. Activate the Rex in Service Mode to confirm repairs and to confirm there was no damage to the REx (from an extreme overheat condition).
